PROGRESS PRINT

Interim Repairs - Parking Lot Area with Shielding Structure

Interim Repairs – Shielding Structure Within Existing Tunnel

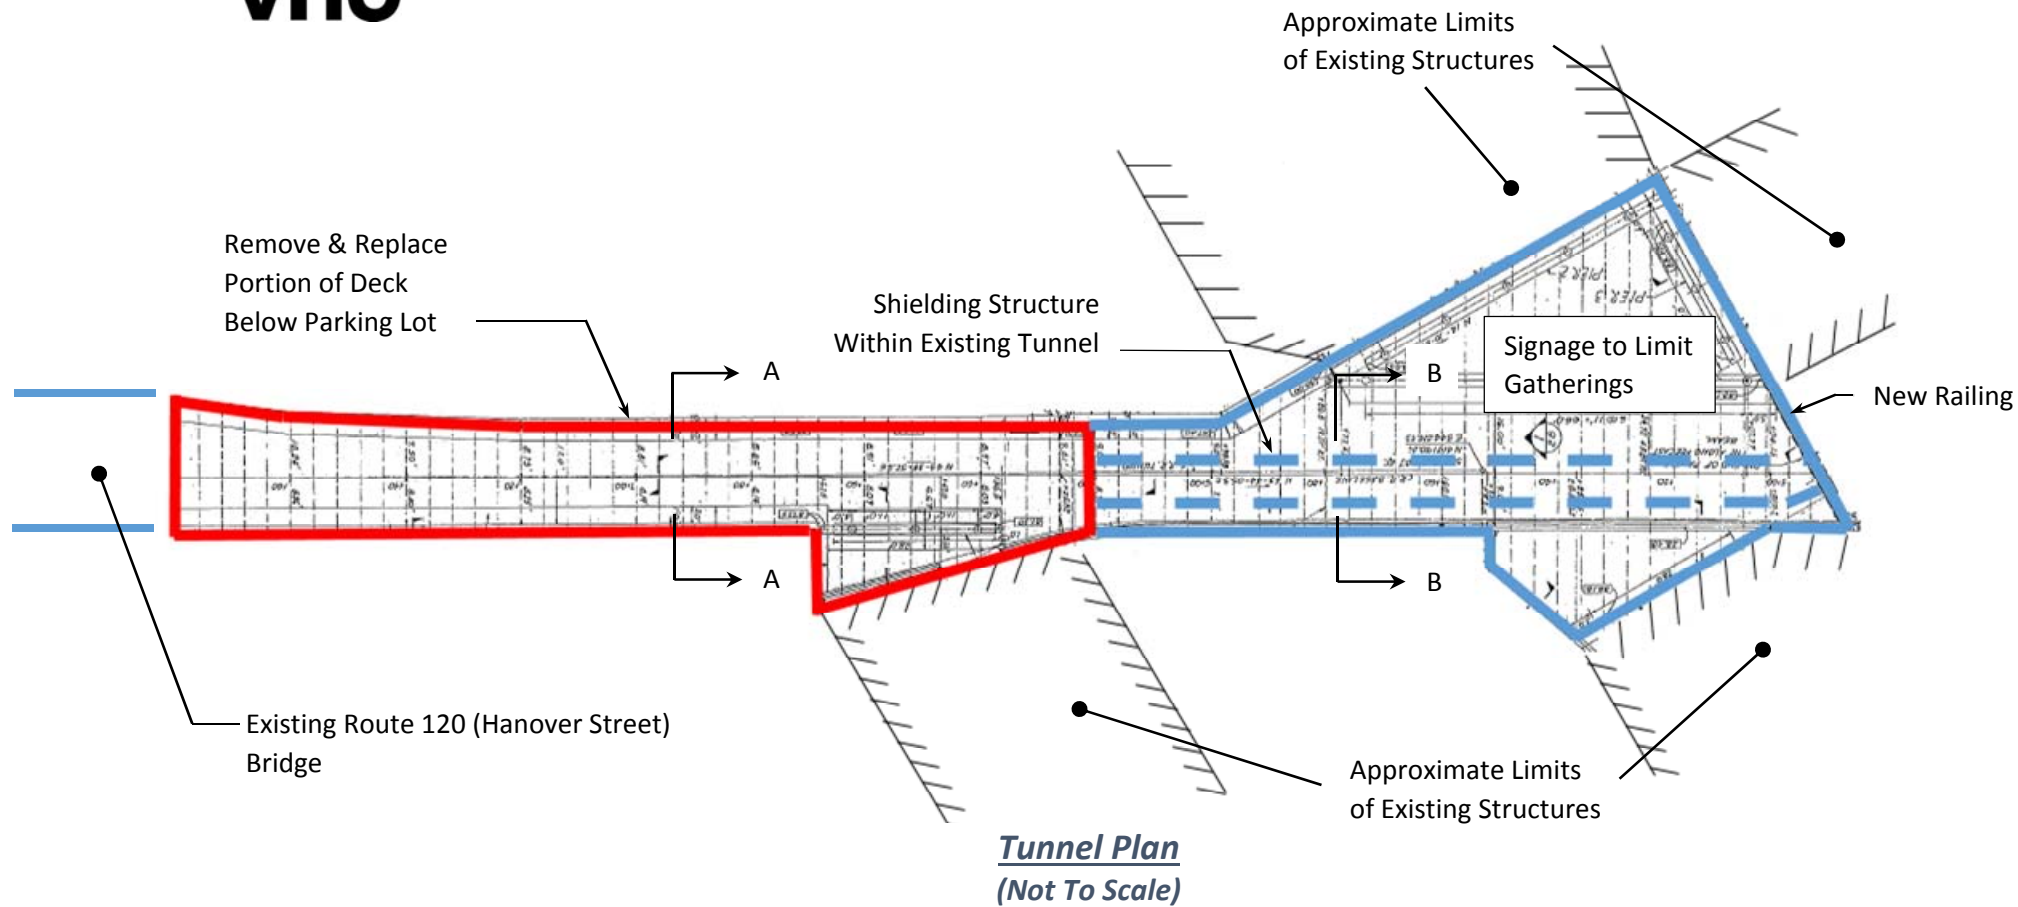
Deck Replacement Below Parking Lot

- Provides parking lot, plaza, and confined tunnel access.
- Includes signage to limit gatherings on plaza.
- Includes a shielding structure below the plaza area within existing tunnel.
- New railings at end of plaza next to stairs.

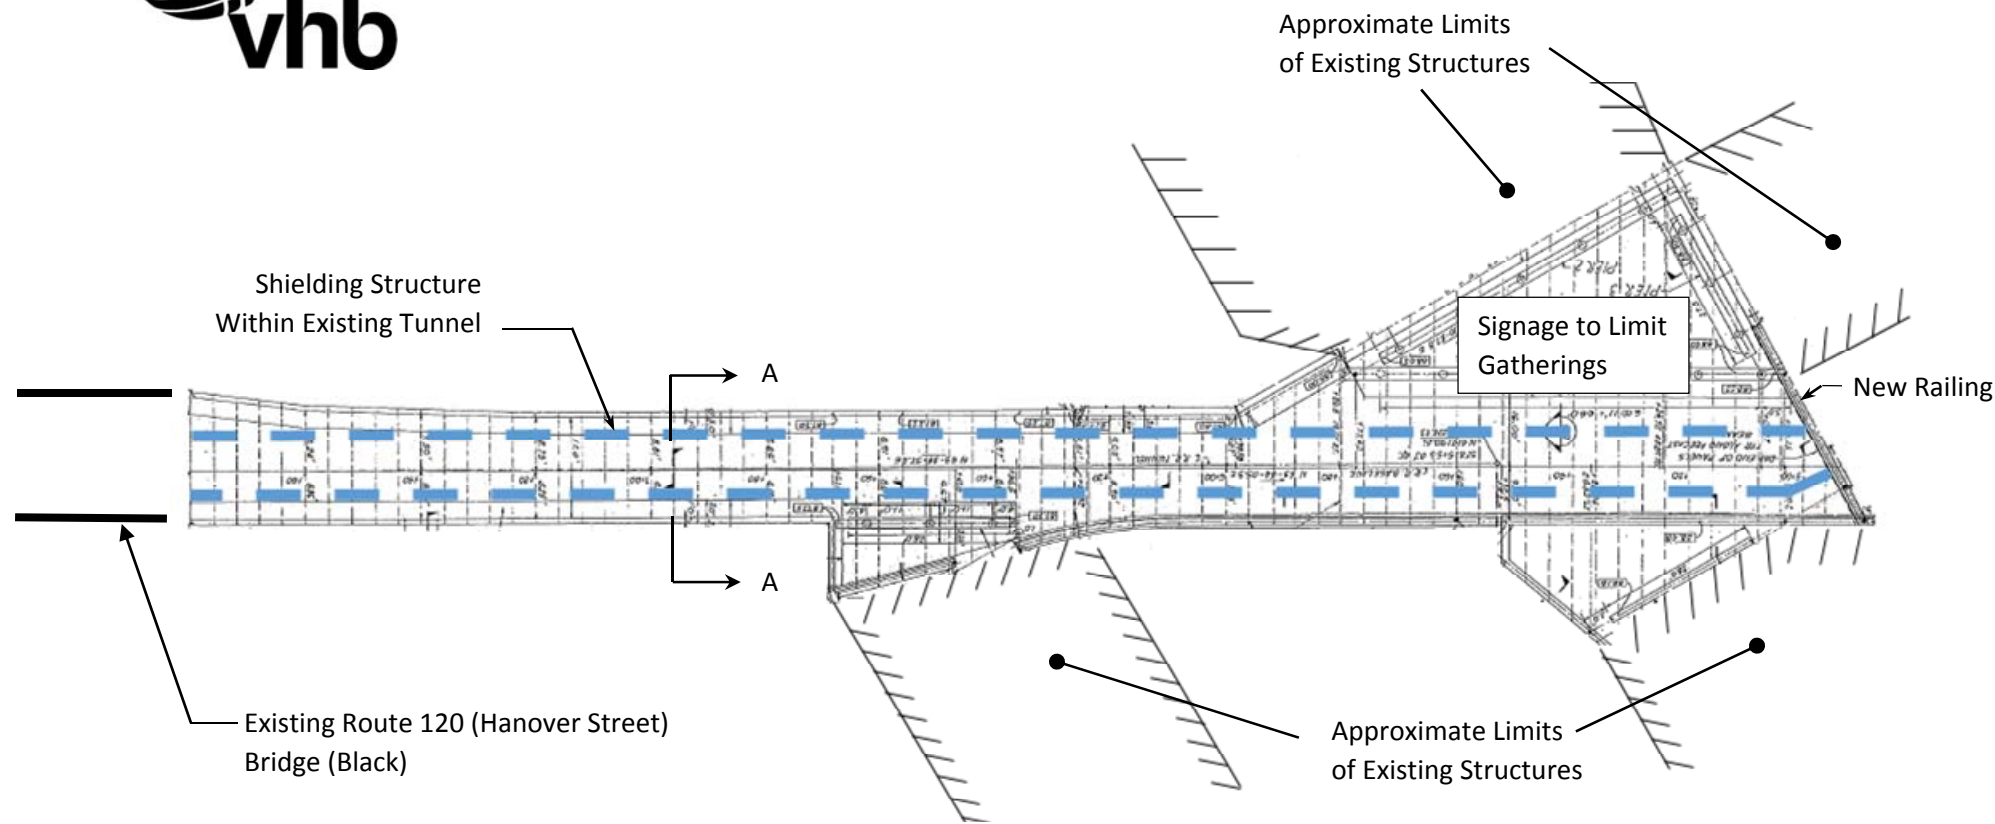
Tunnel Plan
(Not To Scale)

Temporary Structure Inside of Tunnel

- Provides confined tunnel access for pedestrian use.
- Prohibits vehicular parking above tunnel.
- Includes signage to limit gatherings on plaza.
- New railing at end of plaza next to stairs.
